NASA TM-82540

MATERIALS INVESTIGATION OF STS-3 PARACHUTE FAILURE

By Ronald L. Nichols
Materials and Processes Laboratory

July 1983

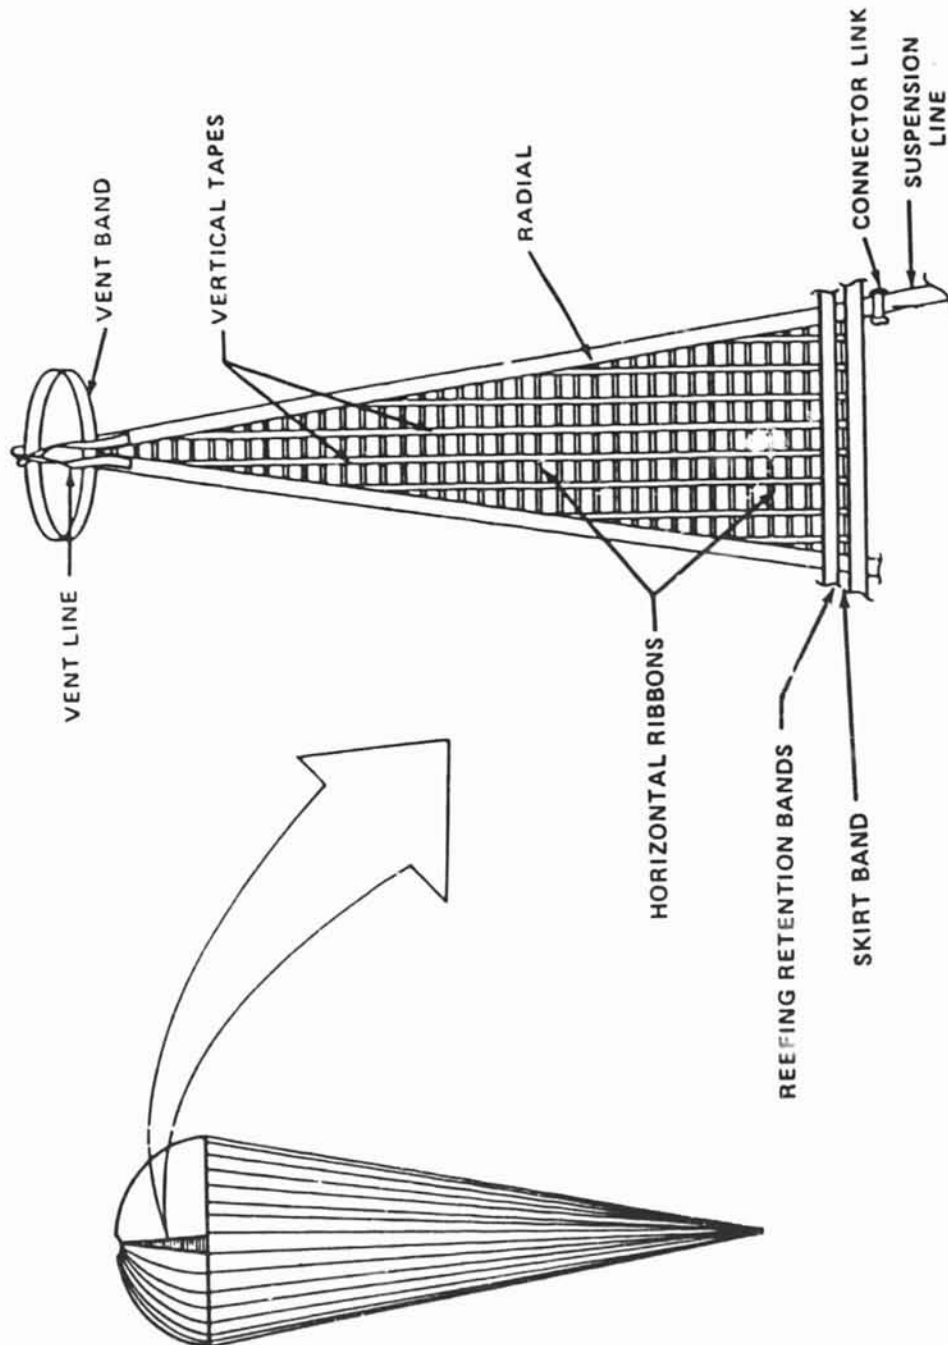
Parachute No. 2 on SRB A-12 was noted to have sustained significant structural damage during SRB reentry. Investigation of the available data relative to this parachute indicates that the frustrum was tilted at a significant angle during deployment of the main parachutes. All three canopies began to carry load, but approximately 2.5 sec after deployment parachute No. 2 ceased carrying load. This data was gathered from reentry film and load cells at the SRB-parachute interfaces. Additionally, it was observed that the flotation devices were detached from parachutes No. 1 and No. 2. Parachute No. 1 was detached from the SRB by the separation nut pyrotechnic devices, and it subsequently sank prior to arrival of the retrieval vessel. Parachute No. 2 did not detach from the SRB even though the separation nuts fired as scheduled. This allowed for the retrieval of parachute No. 2. It was returned to the Parachute Refurbishment Facility where it was washed and dried according to normal procedure and spread to allow observation of the damage. Figure 1 identifies those structural elements of the SRB main parachute involved in this investigation.

Figure 1. Parachute canopy structural components.

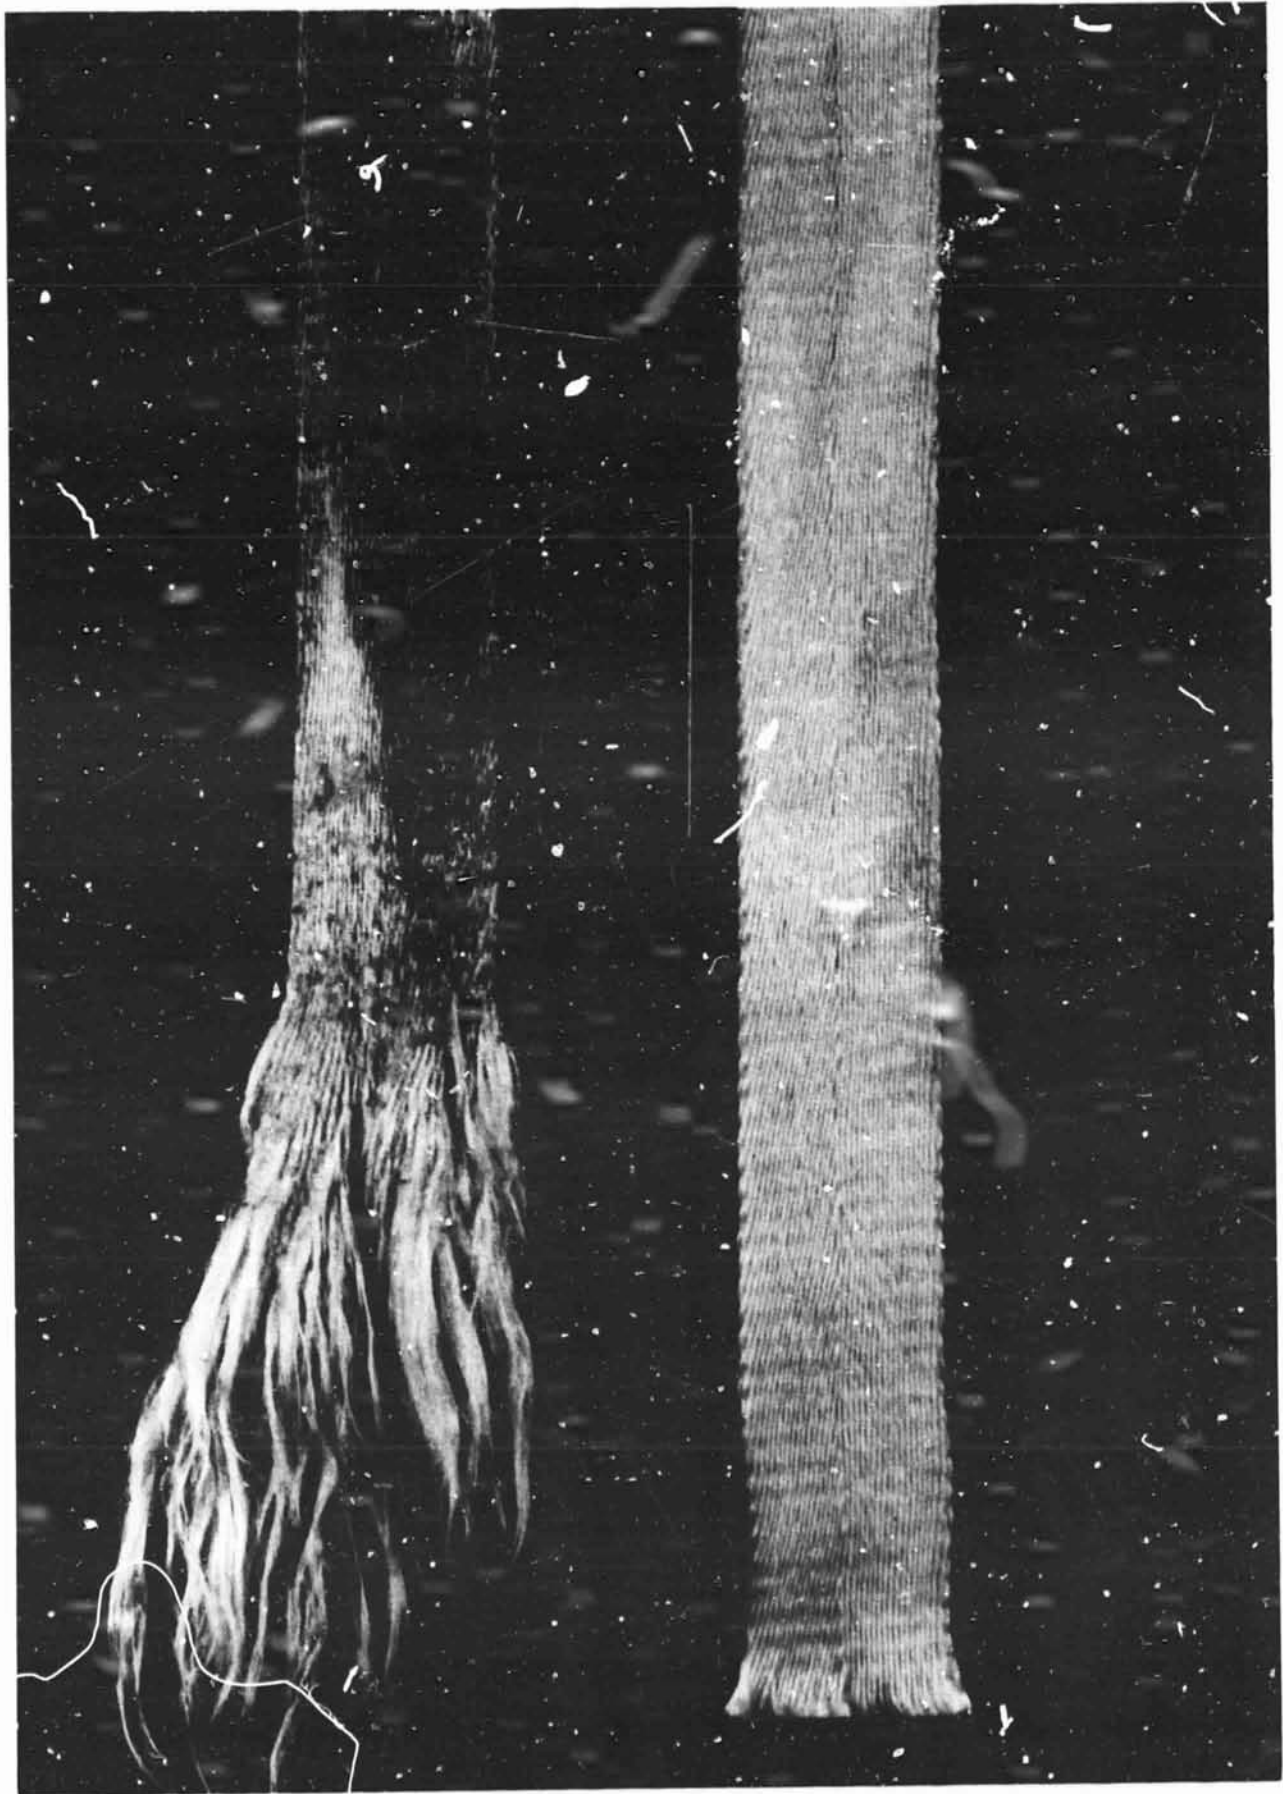
The vent lines are extensions of the radial structural components and extend across the apex of the canopy above the vent. One vent line that connects radials 3 and 51 together was completely severed. A green stain was apparent on the vent lines extending from the radial No. 42 to No. 59 forming a triangular pattern near the vent band. A vent band was broken at approximately 3 in. from the intersection of radial No. 51. The broken vent line is heavily stained with a green color. Figure 2 shows the failed vent line and the heavily stained area.

Tensile specimens were made from the broken vent line from the failed parachute. The average breaking strength of these samples was 3300 lb when pulled to failure on an Instron tensile testing machine at 10 in./min. The vent line material is initially rated at 6000 lb.

Figure 2. Broken parachute vent line.

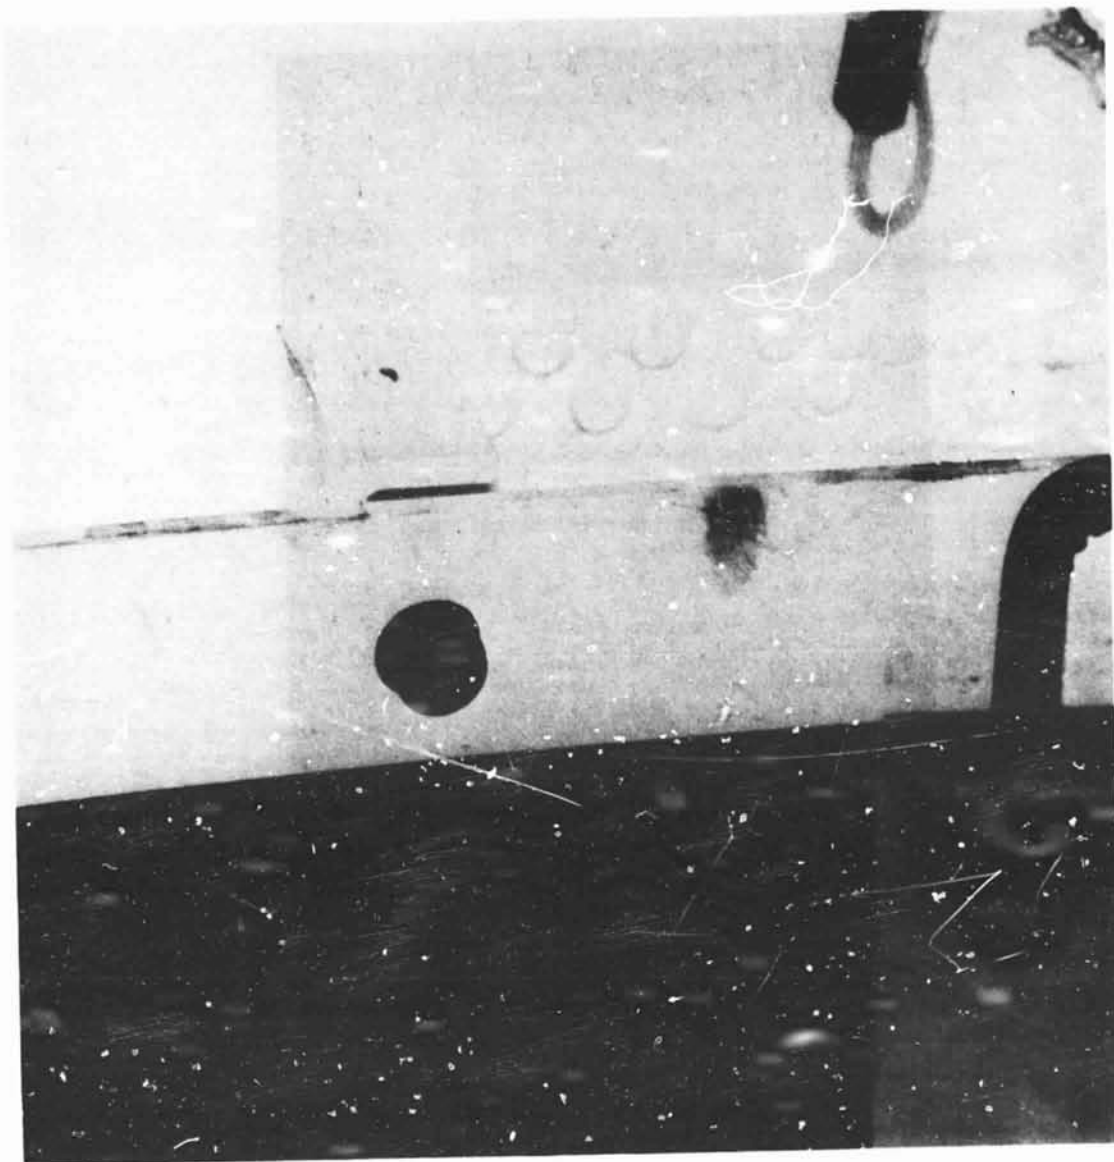
A rubber bumper is located on the lower rim of the frustrum to serve as a bumper for the frustrum location aid (FLA). The rubber bumper shown in Figure 5 has significant stains on its upper surfaces that may have been caused by rubbing contact with the parachute as it was deployed. Viewing of the films to determine the angle of the frustrum during deployment indicates that parachute No. 2 may have contacted the rubber bumper. Figure 6 shows the stains on the rubber bumper. They appear to be deposits of molten material characteristic of nylon. Efforts expended did not result in the positive identification of the source of these stains.

It appears at this point that the FLA bumper damage did not contribute to the parachute failure. Additionally, no evidence was found in the build records nor from testing of materials from main parachute No. 2 that indicated that any substandard materials contributed to the parachute's failure.

Figure 5. Frustrum location aid bumper.
